Nailing Flange Repair

Service Technique

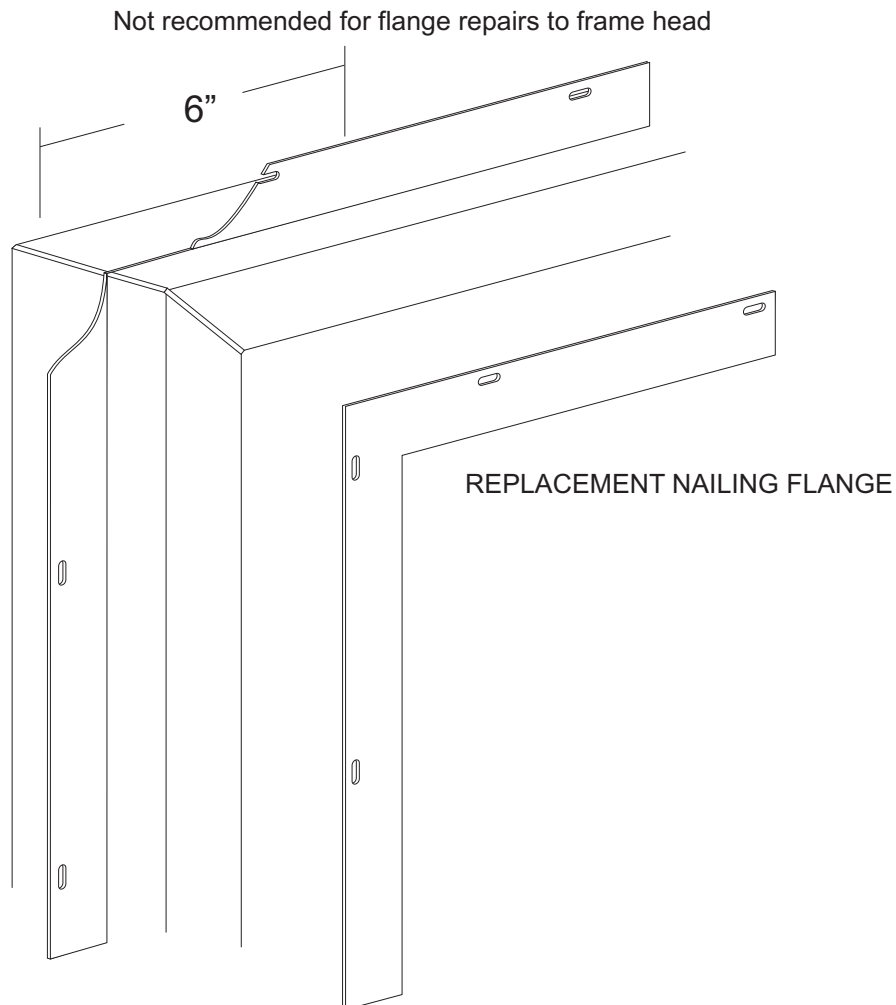
Integral nail flange repair to broken flanges is acceptable for vertical jambs or horizontal sills only and not recommended for head flange (as illustrated below).

A continuous bead of sealant should continue in the path of the nail flange pre punched holes, even where a portion of the fin is missing. To achieve this, the bead must be applied to the back side of the flange prior to installation, then integrating the bead on the wall. A 3/8" bead of sealant should be applied between the frame and the wall and along the entire path of the breakage on both sides. Another sealant path must be applied on the edge of the fin. A fastener must be applied within one inch of the break line on both sides. Finally, a weather barrier flashing tape such as "Tyvek" tape must be imbedded into the sealant. The tape must be a minimum of two inches wide with a minimum of 3/8" adhering to the side of the main frame.
