Retro-fit with Flush Fin frame

580 Single Hung Flush Fin Illustrated

Retro-fit Installations

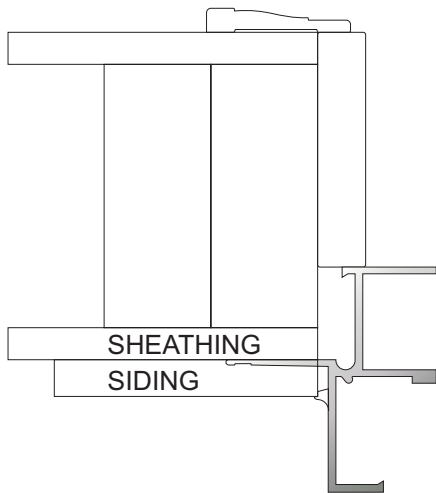
Realizing that building structures and conditions will vary, it is acceptable and sometimes unavoidable that installation procedures will be different. The image below illustrates one common method as an acceptable modified installation where the fastener is located through the frame as opposed to through the nailing flange, or with the nailing flange removed.
